*Journal of the
American Musical
Instrument Society*

VOLUME VIII • 1982

The Restoration of a 1608 Trombone by Jacob Bauer, Nuremberg

GARY M. STEWART

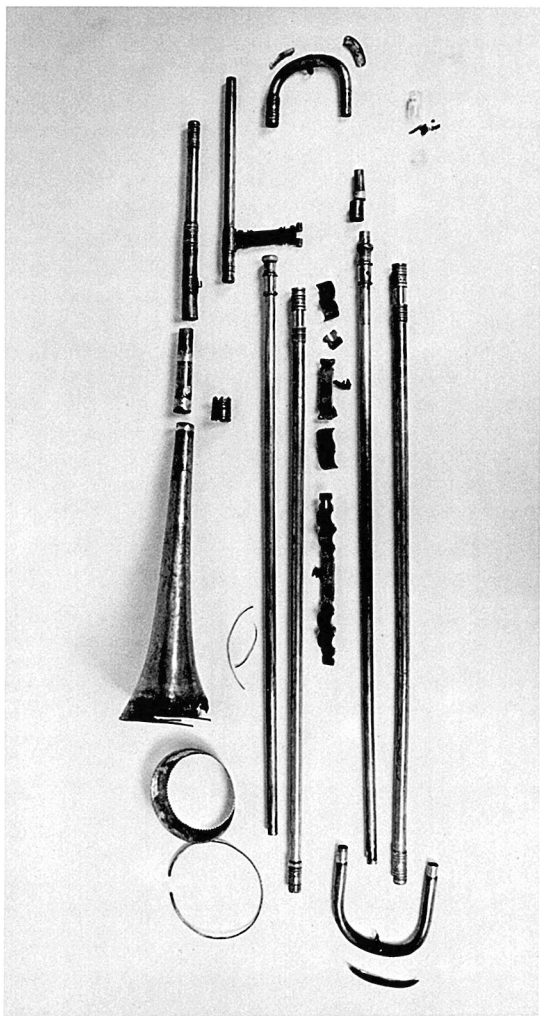
The instrument came into this country several years ago from Europe. Judging from wear patterns on the slide handles and slide tubes, it had been well used; and, as with any delicate object not provided with a case, it had received a few knocks. It had in fact deteriorated to the point of being held precariously together with brass patches and a lot of soft solder. From this stage it had been completely disassembled, for some unknown reason, and left as a collection of bits and parts in a shoe box, plus the slide tubes. The trombone was in this condition

when work was commenced upon it. Figure 1 shows the parts of the instrument, including some curious pieces which had been used in the past for repair.

FIGURE 1. The parts of the Bauer trombone before restoration.

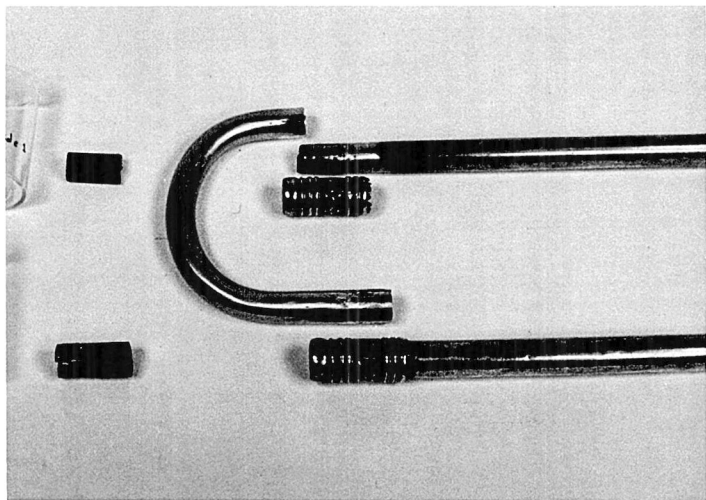
Two pieces of outer slide or original slide bow that had been broken off at some time were found inside the ferrules where the slide bow is inserted (fig. 2). These had probably been cut or broken off when an ill-fitting replacement bow was soldered in place. The pieces, each approximately 3/4 in. long, were removed and saved. One is marked with the symbol: ///, as are several other parts of the instrument.

FIGURE 2. The slide bow of the Bauer trombone, with the extra pieces found inside the ferrules.

The ferrule on the mouthpipe side of the outer slide (fig. 2) was removed with low torch heat and penetrating oil. The tubing just inside the ferrule cracked on removal. This was where silver solder was first

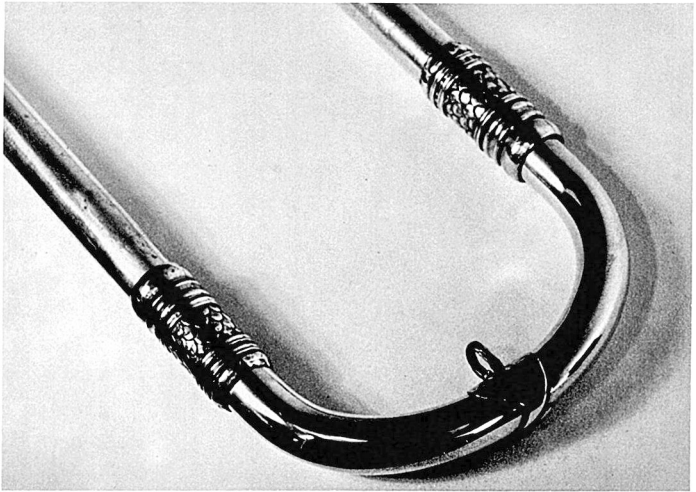
FIGURE 3. The replacement slide bow of the restored Bauer trombone.

tested. The freed ferrule was soldered with soft solder to a new slide bow which had been formed from 19-gauge sheet brass and copied from the original bell bow in all dimensions (fig. 3). (The bows on most early trombones and trumpets seem to have been almost interchangeable.) The new slide bow does not enter the ferrule full-length, but only 1/2 in., because of a piece of original (?) slide bow firmly attached to the ferrule's interior. The other side of the slide bow telescopes into the ferrule of the second leg for a friction fit. The lower banner ring and new tips for both sides of its base were soldered to the new slide bow with soft solder. The new tips were finished and engraved to match (fig. 3). The original tips seem to have been removed to fit the slide bow just replaced, which had been fitted with a rather crude bow guard.

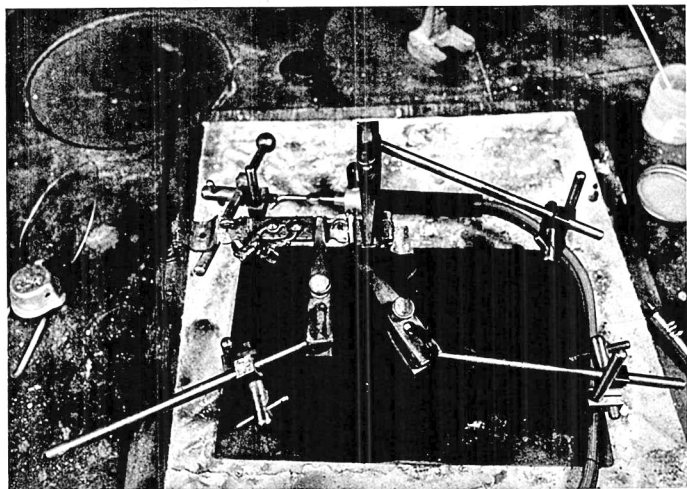
FIGURE 4. Pieces of the inner-slide handle of the Bauer trombone, held in a multiple third hand.

The badly broken inner-slide handle was cleaned of soft solder under a microscope—a tedious procedure. Remaining traces of solder were removed with locally applied, concentrated nitric acid, as described above. The areas near the four fractures were brushed with a glass-bristle brush. Then, held firmly in position with a multiple third hand, the pieces of the handle were silver-soldered (1250°F.) with a micro

torch to localize heat (fig. 4). A small sliver of brass was added to the right rear break, where the loss of original metal caused improper mating of inner and outer slides (fig. 4). The missing part of the left-side hasp was replaced with a piece of brass cut, fitted, and engraved in keeping with its counterpart on the outer-slide hasp (figs. 5 and 6).

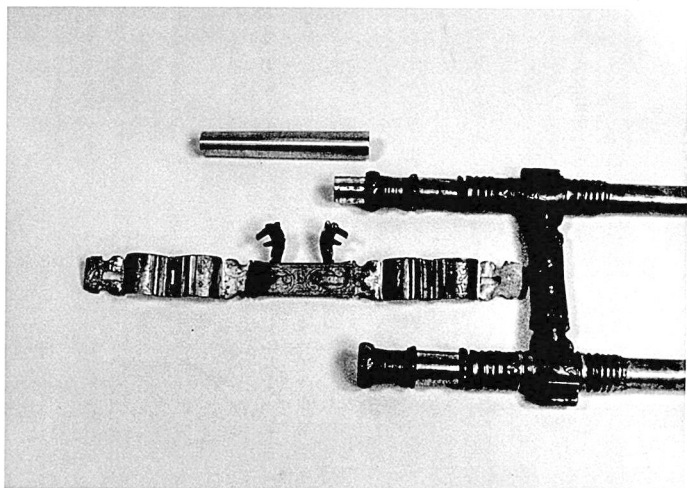
FIGURE 5. The top of the slide of the Bauer trombone, with the restored inner-slide handle and the replacement tube made to connect the slide joint to the bell joint.

Missing pins for locking inner slides to the inner-slide handle were made of brass stock and installed with soft solder (fig. 7). The short tube connecting the slide joint to the bell joint was missing, presumably broken off at some time. Photographs and drawings of as many similar instruments as possible were consulted, and the length was fixed at 2 in., plus the length inserted into the bell joint. A piece of tubing was made and fitted to the remains of the original on the inner-slide second leg with soft solder (figs. 5 and 6).

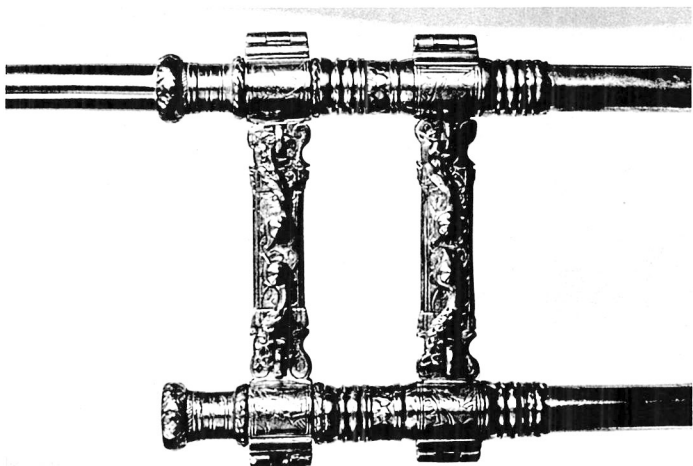
FIGURE 6. The top of the slide of the restored Bauer trombone, fully assembled.

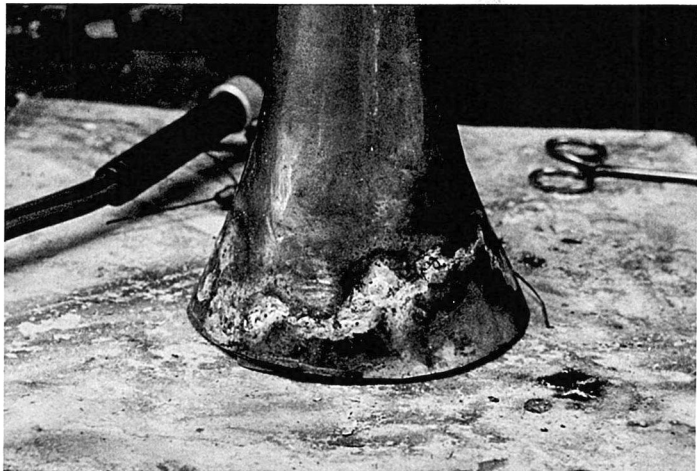
FIGURE 8. The repaired bell of the Bauer trombone (garland and bell rim removed).

Soft solder around the damaged area of the bell was removed with scrapers and nitric acid. The pattern of the major loss was traced onto a piece of 0.010 in. sheet brass formed to, and held against, the ragged edges. It was cut to fit the loss in a butt joint. The piece was tacked in with several spots of hard gold solder, and the entire joint was soldered

in short sections to minimize effects of heat warping (fig. 8). Gold solder was chosen, rather than silver solder, for its color, which is a fair match for brass. A micro torch was used to localize heating and possible damage. Several cracks and fractures in nearby original material were soldered at the same time.

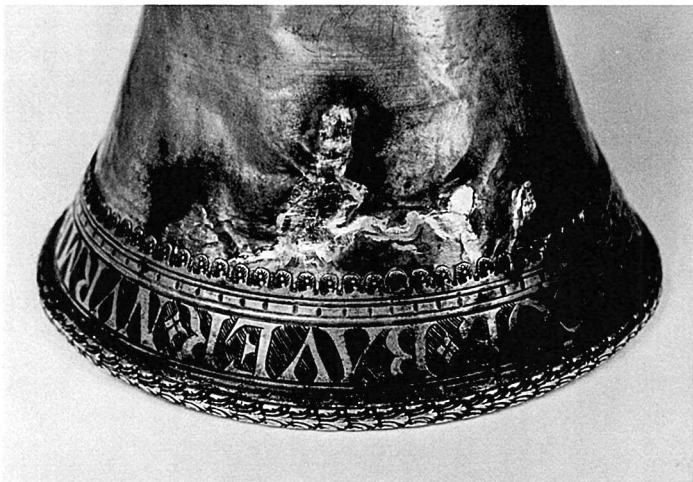
Enlargement of the area of the bell at the apex of the loss—behind the name “BAVER”² on the garland—caused the garland not to fit. The enlargement was probably due to the nature of the damage, the repair (and possibly re-repair) of the area, or a combination of occurrences. A cut through the patch and into the original approximately 3/8 in. was made to relieve the enlargement by taking out a V-shaped wedge of the patch and overlapping the original material. The closed V of the patch and the overlapped original material was soldered with gold solder (fig. 9).

FIGURE 9. The bell of the Bauer trombone (garland and bell rim attached).

at the joint where it had been silver-soldered originally. Soft solder was removed from the area, and the joint was repaired with silver solder. The garland and bell rim were fitted and soldered in place with 40/60 soft solder. The remains of the thin ring of sheet brass on the inner bell rim were resoldered with 70/30 soft solder (fig. 9).

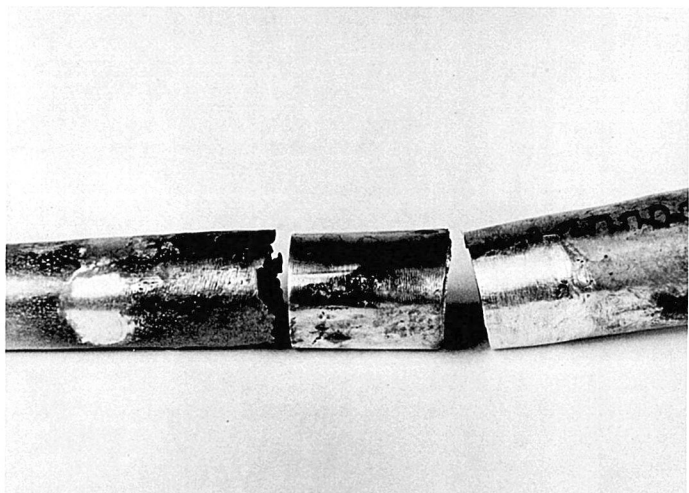
The wrap-around patch soldered to the joint just in back of the bell joint was removed, and no trace of original metal was found. Tracing the two pieces of bell joint on paper showed a piece 7/16 in. long missing in front of the support strut, and a piece 1/4 in. long missing at the end (not including the portion which is the male part of the joint) needed to make the bell joint's parabolic shape complete.

FIGURE 10. A section of the bell joint of the Bauer trombone, with original and replacement pieces.

Pieces of tubing to replace missing parts of the bell joint were made of sheet brass using the same tooth-pattern seam found on the original. The pieces of replacement tubing were fitted to the originals, and only a few snippets of material had to be removed from the front edge of the rear original piece (fig. 10). These were saved. The closely butted seams were then gold-soldered, using a micro torch (fig. 11). The rear edge of the front bell piece had been beveled at some time, probably to fit a patch around it (fig. 10). No material was removed to remedy this since the bevel was quite long (1/4 in.). The joint between it and the adjoining replacement piece is therefore somewhat weaker than the other joints.

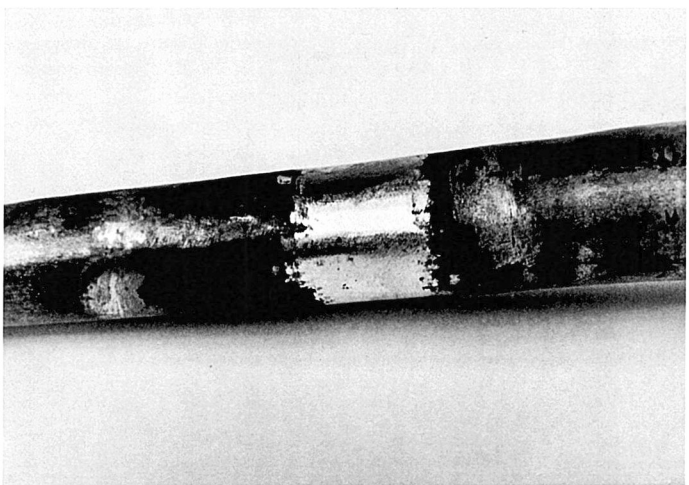
FIGURE 11. The repaired section of the bell joint of the Bauer trombone.

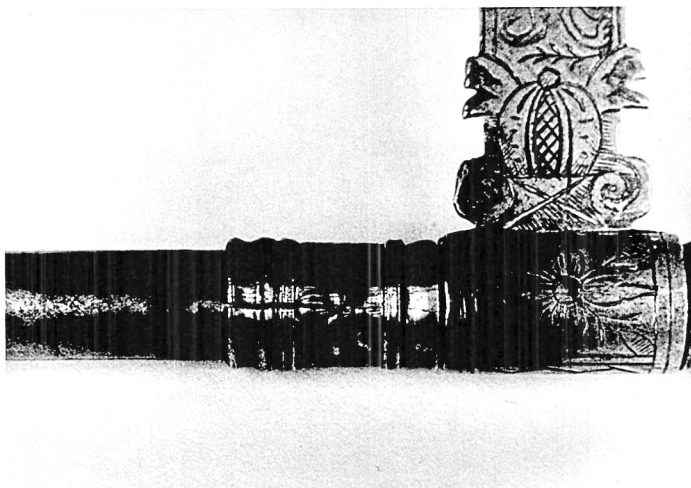
The support strut and its trailing ferrule had been placed in reverse order at some time, resulting in the ferrule being split halfway down its seam when it was forced forward (fig. 12). It was straightened and the break silver-soldered.

FIGURE 12. The support strut and (cracked) ferrule of the Bauer trombone.

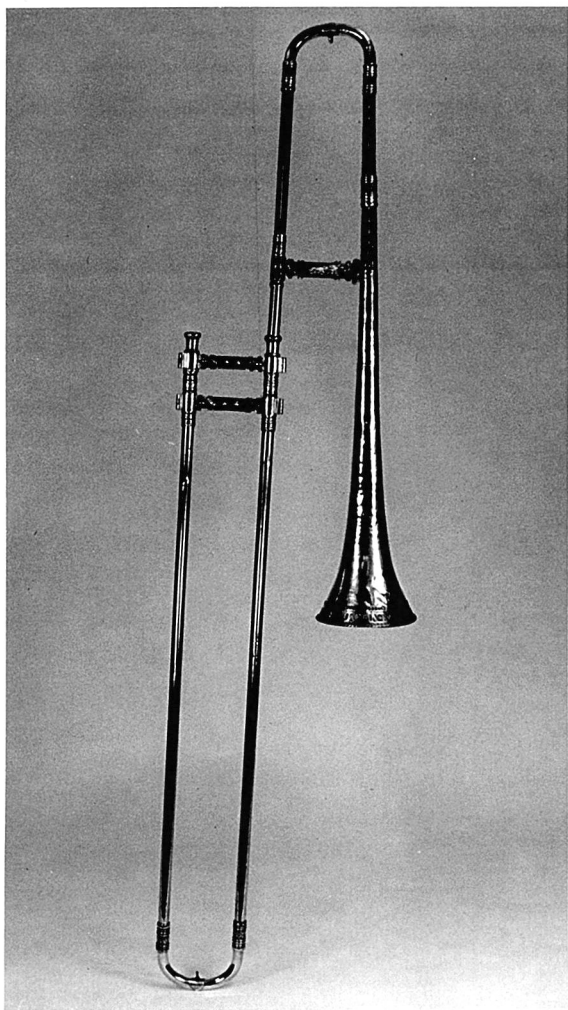
FIGURE 13. The restored Bauer trombone, fully assembled.

rectly adjacent to the high-temperature soldered areas were smoothed with FFFF pumice on moistened swabs. The entire instrument was cleaned with warm Rochelle salt solution³ applied with a sponge, making special effort to prevent removal of the darkened background of the engraving on the garland, slide handles, ferrules, and the bell-joint support strut. The instrument was finally cleaned with a solution of 0.3 micron alumina micropolish, benzotriazole in ethanol (3%), and a small amount of deionized water, on swabs; it was then wiped with benzotriazole⁴ in ethanol (3%) on swabs. Then the instrument was assembled, using hot shellac to cement the friction joints in the bell section and slide bow (fig. 13).
